Incident Report: 12/08/04 **Goodrich Open Burn Monitoring**

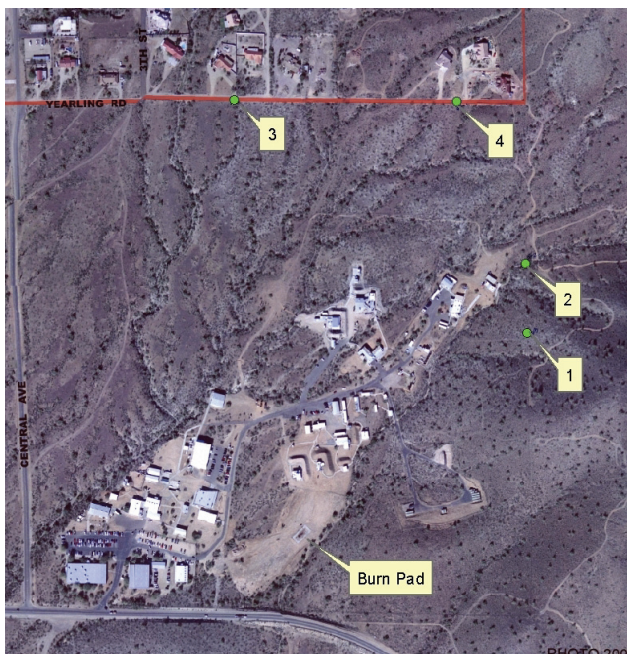
Monitoring Strategy: The HART monitoring strategy relied upon the use of the HART monitoring van as a meteorological / air quality monitoring base station supplemented by portable air quality monitoring equipment at three additional locations on the northern and eastern boundary of the property. HART personnel met with UPCO personnel to review the monitoring strategy and arrange for access to the eastern perimeter fence line. An aerial photo of the area indicating the monitoring locations and location of the burn pad used to dispose of the materials is shown below in Figure 1.

Figure 1. Monitoring and Open Burn Locations

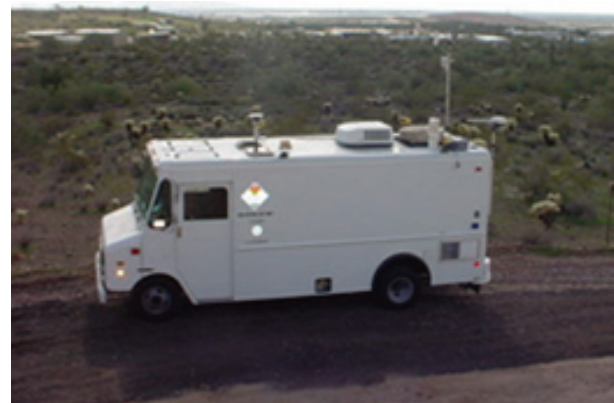
HART Monitor Deployment: HART personnel departed the ADEQ offices at 9:43am on December 8, 2004. HART personnel included the HART Manager Shawn Kendall and HART Responders Randy Redman, and Dan Catlin. The HART monitoring van arrived at monitoring location #4 at approximately 10:00am. The TEOM analyzer, data logger and computer were turned on and the wind monitoring equipment was deployed and aligned by 10:35am. A DUSTTRAK analyzer and mini-vol sampler were positioned on the roof of the monitoring van. A photograph taken later in the day is included as Figure 2 showing the view of the top of the monitoring van with the Goodrich facility and downtown Phoenix in the background. The winds at the monitoring van were consistent with earlier observations and beginning to shift

Figure 2. HART monitoring van at monitoring location #4 (looking south)

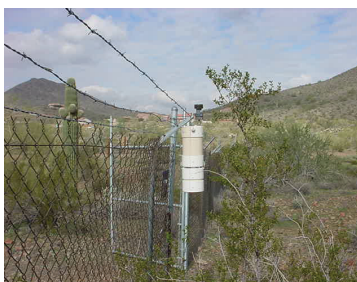
A DUSTTRAK analyzer and mini-vol sampler were deployed at monitoring locations #2 at 12:30pm. Collection of 5-minute average PM₁₀ concentrations began at 12:30pm. Figure 3 is a view to the north showing the mini-vol sampler mounted on the perimeter fence, with the hills in the background to the north.

Figure 3. Mini-vol sampler at monitoring location #2 (looking north)

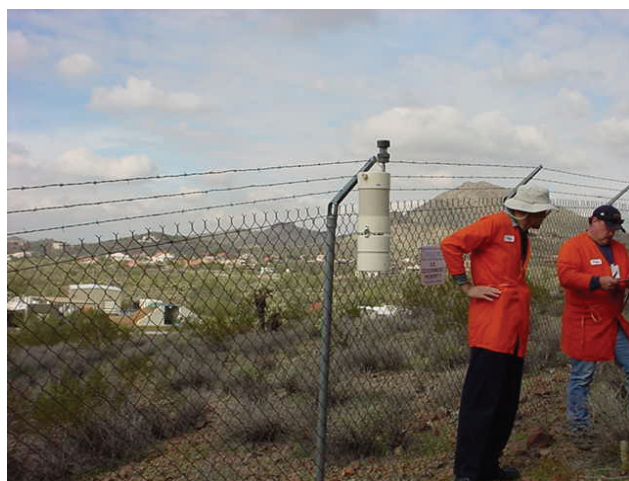
The HART responders proceeded to monitoring location #1 and set up a DUSTTRAK analyzer and mini-vol sampler at a location to the south of monitoring location #2. Collection of 5-minute average PM₁₀ concentrations began at 12:35pm. Figure 4 shows the mini-vol sampler

Figure 4. Mini-vol sampler at monitoring location #1 (looking northwest)

mounted on the perimeter fence at location #1 (HART responders Dan Catlin and Randy Redman are shown checking field notes on the right).

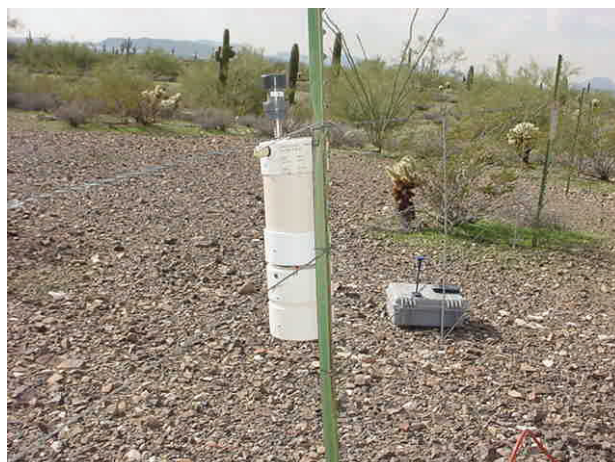
Yearling Road. Monitoring location #3 was established approximately 0.2 miles east of Central Avenue on the Goodrich's north property boundary along Yearling Road. A DUSTTRAK analyzer and a mini-vol sampler were set up at this location. Collection of 5-minute average PM₁₀ concentrations began at approximately 12:55pm. A photograph of the mini-vol sampler and DUSTTRAK analyzer deployed at monitoring location #3 is shown in Figure 5.

Figure 5. Mini-vol sampler & DUSTTRAK at monitoring location #3 (looking west)

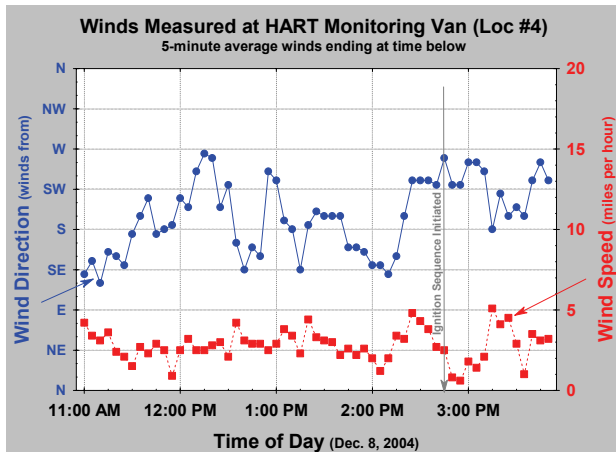
Five-minute average wind speed and direction was stored throughout the pre-ignition and open burn monitoring period and is shown in Figure 8. Winds transitioned from the southeast to the southwest as expected and stabilized

Figure 8. HART Monitoring Van Winds From 11:00am to 4:00pm on Dec. 8, 2004 (5-min avg)

at approximately 2:25pm. Surface flow at the HART monitoring van shifted to the south-southwest at approximately 3:15pm for 25 minutes and then continued from the southwest.

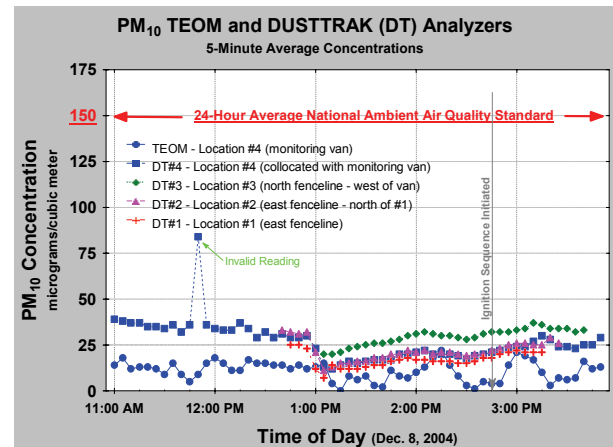
Data collected from 11:00am to 4:00pm is presented in Figure 9. At 1:00pm the winds shifted from the southwest and all PM_{10} concentrations dropped due to a shift in the background concentration from the southwest.

Figure 9. PM_{10} Monitoring Data Collected 11:00am to 4:00pm on Dec. 8, 2004 (5-min avg)

All DUSTTRAK monitor measurements tracked well with one another. All concentrations were well below the 24-hour average National Ambient Air Quality Standard (NAAQS). The variation of concentrations measured by the TEOM analyzer after ignition of the burn were identical to the variations measured an hour prior to the burn. Samples from the mini-vol samplers were below detection limits.
